COUNTIES (MD/PA) WASHINGTON/FRANKLIN
M&D milestone no. 91 (94)
MHT-HSI no. WA-IV-091

FIELD SHEET: MASON & DIXON LINE, MARYLAND-PENNSYLVANIA BOUNDARY MARKER SURVEY

Off N/S Waldheim Road, Pen Mar, MD-PA. In settlement of Pen Mar, SW/S W.M.R.R., about 25' N of end of Rd opposite last of three houses in row on S/S; on N tip of South Mountain in deciduous woodland slope. Can be seen from Rd when vegetation is dormant.

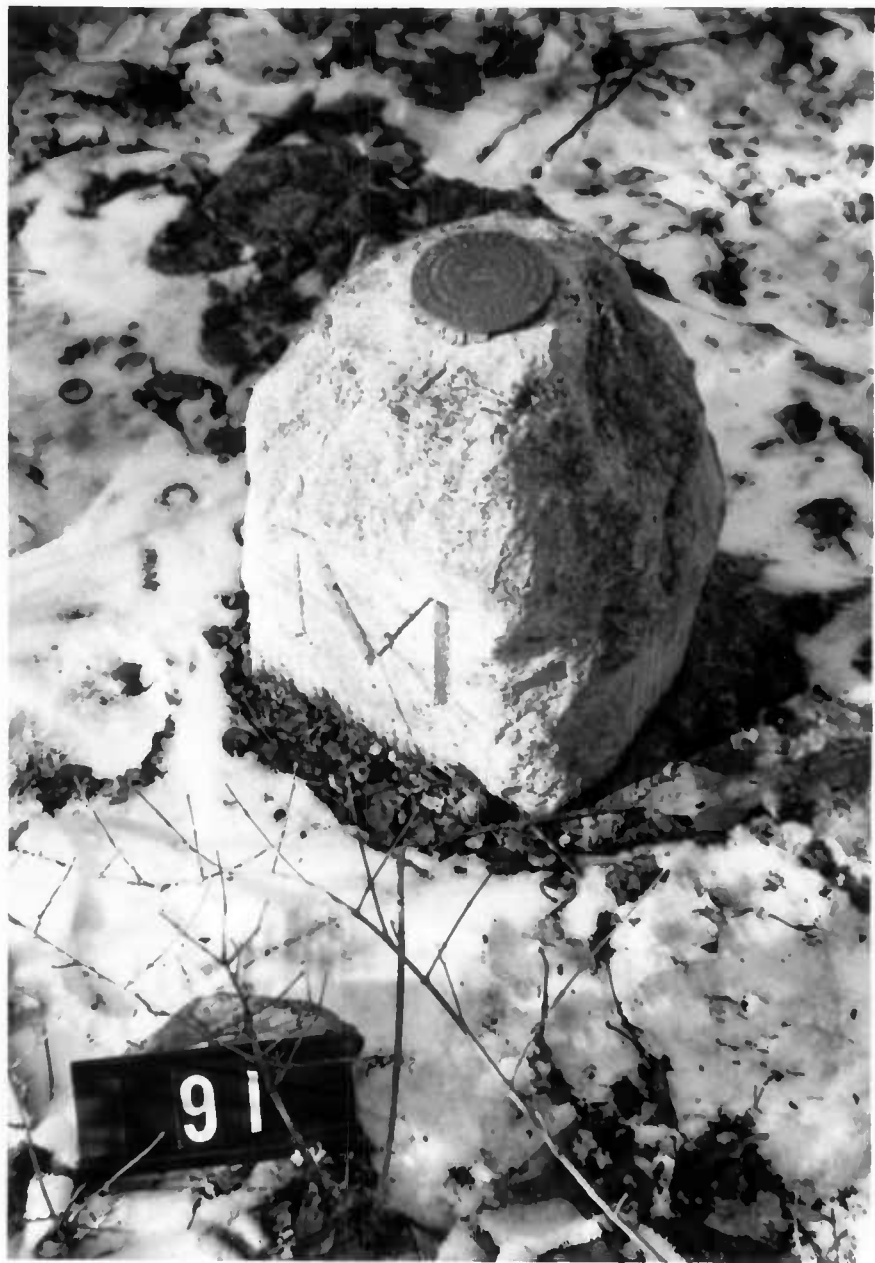
HAYDEN EDISON WEST LACE: MILESTONE 71 (24)
SE CORNER (H-)

N face (PA): 11 1/4" wide x 11" high; P & most of circle panel clear; fluting & margins gone; bad chips all edges & corners
E face: 11" wide x 11" high; bits of fluting, no margins remain; bad chips all edges & corners
S face (MD): 11 1/2" wide x 11" high; M & some of circle panel clear; patch of fluting, no margins remain; bad chips all edges & corners
W face: 11 1/4" wide x 11" high; most of fluting, no margins remain; bad chips all edges & corners
top: no planes or fluting remain; now dome-shaped from huge chips all top edges & corners, especially E/S
bench mark: BM 1317; USC&GS disk set into apex (1939)

91 (94). Original M&D milestone of 1767 in place, in fair condition, firmly set. Letters clear and intact, but most of other embellishments gone. Stone now dome-shaped from large chips all edges and corners. Cage no longer in place, but stone somewhat protected by site.

Somewhere along the line, MGS will want to establish the demise of the wire cage; ^{surrounding} contact/property owners to establish source of vandalism (chipping of stone); and set a witness post. Since the stone also serves as a USC&GS BM, the history of these problems may have already been determined.

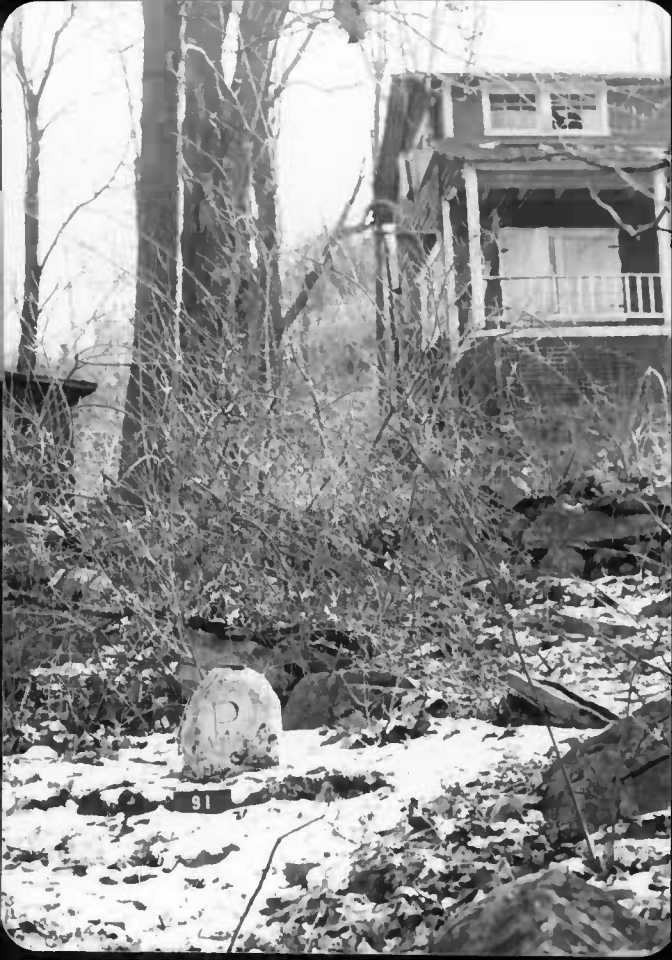
MED WEST LINE: MILESTONE 91 (94)

N/S LOOKING S TOWARD
WALDHEIM RD. E LAST HOUSE
